Micro-scale effects over an operational wind farm: CFD wind shear study

Antonio Angulo, Pep Moreno, David Madueño
ALSTOM Ecotècnia

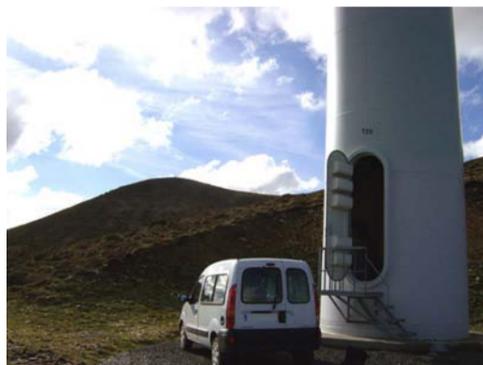
View of the hill from T20. The top of the hill is 415m away from T20 and 60m higher.

At a first glance, after discarding wakes from surrounding wind turbines, we suspected of a re-circulation problem caused by a nearby, abrupt, higher hill located 430m west from the two affected turbines.

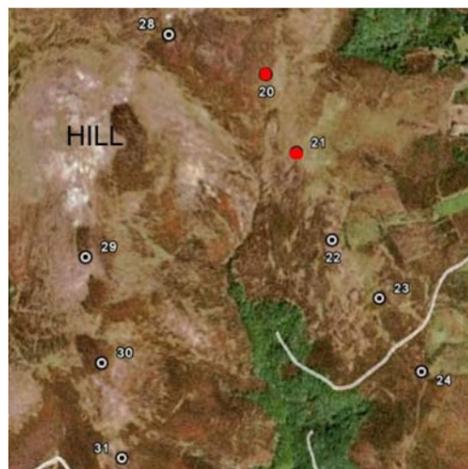
General view of affected turbines (T20 and T21, in red) and neighbouring turbines included in the study (T28 and T22).

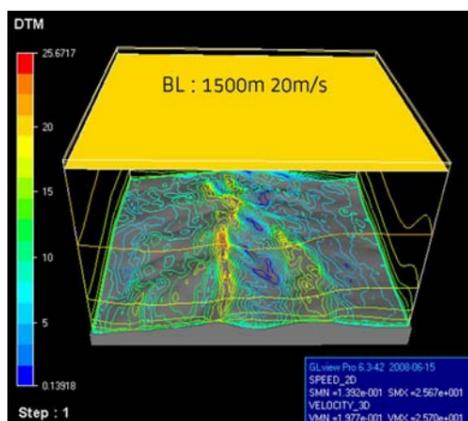
Workspace for CFD simulation. The speed displayed is not scaled with the wind farm measured data.

We performed the CFD in a workspace with a 9x12km topography and a grid with a minimum cell spacing of 11.9m. The upper boundary layer was set to fixed pressure.

An extended iterative process was necessary to achieve the convergence for west wind directions. Our attention focussed in 270 and 250deg.

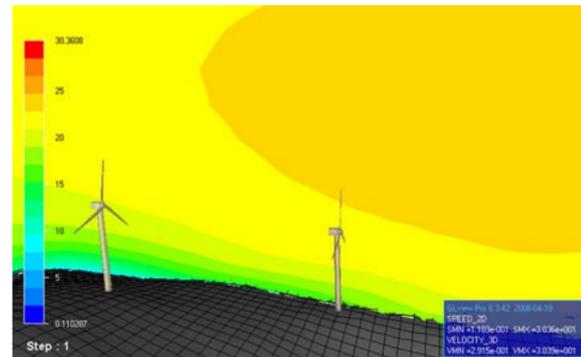
2D speed cut-plane orthogonal to 250deg in T21 position.

Although no recirculation was found at the lee side of the hill, a very high wind shear was detected at the two affected wind turbines positions in contrast with the much flatter profile found at the neighbouring turbines (see T28 for example).

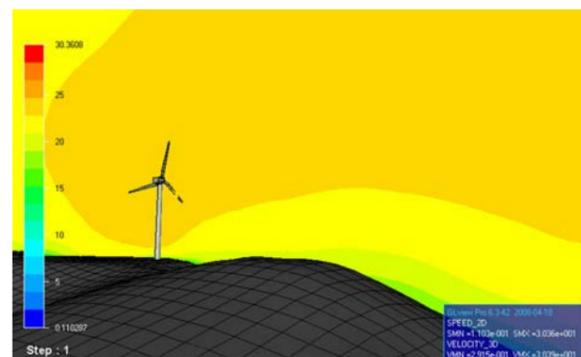
2D speed cut-plane orthogonal to 250deg in T28 position.

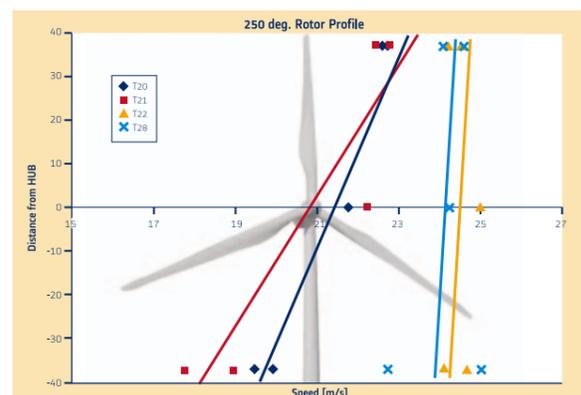
Speed profile at hub height. Lines are only indications.

The error reported from the turbine control is usually associated to very different loads over the blades. That load gradient spreads to the nacelle and are detected as a structural vibration error. A large wind shear could perfectly be the source of such load differences.
